**INSTRUCTIONS FOR TRANSPORTATION,  
HANDLING, STORAGE OF THE DRUMS AND  
LAYING OF THE CABLES**

**Revision : 01**

<b>Revision:</b>	01		
<b>Date:</b>	November 2025		
<b>Written By</b>	Elie Diab		
<b>Approved By</b>	Elie Khoury

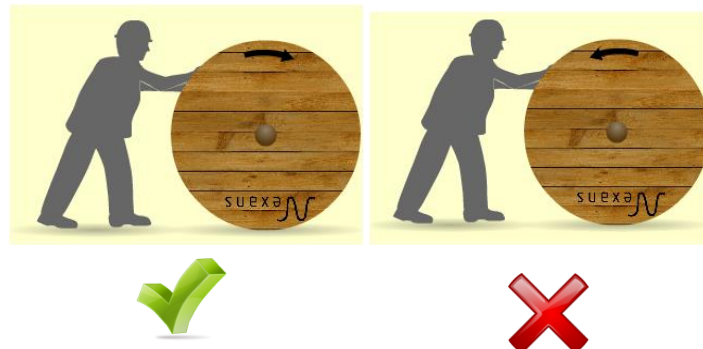
Drum flanges are marked to provide vital information to assist with the handling of the drums and the installation of the cable. This information includes drum weight, a mark on the flange indicating the end of the cable, and an arrow indicating the direction the drum is to be rolled during rolling or transportation.

The rolling of the drum in the direction of the arrow ensures that there is no tendency for the cable to loosen its wind on the drum. It should be noted that when pulling the cable off the drum and installing

It should be noted that when pulling the cable off the drum, the arrow (painted on the flange of the drum) will point in the opposite direction to the rotation of the drum. This is an expected practice.

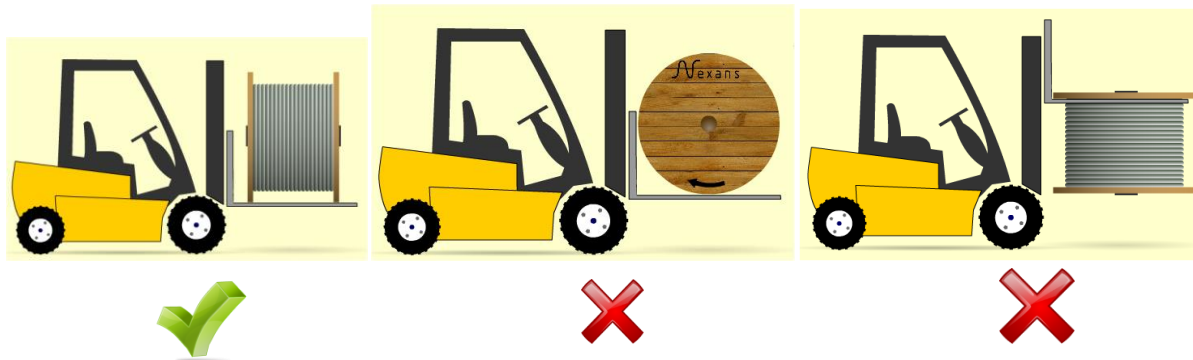
In general, the forklift truck method of drum handling is only applicable where a hard and level ground surface is available. This is required in the intended storage area. In this case a forklift capable of lifting about 12 tonnes will be required (maximum drum weight plus contingency). It is also necessary to ensure that the forklift truck tines are capable of traversing the width of the drum and provide support to both flanges.

For the smaller drums, tines of 1200 mm length will be satisfactory. The larger drums will require tines of 1800 mm length. For the larger drums, for example containing 33 kV or 132 kV cables or long lengths of cable, it will be necessary to have tines at least 2500 mm so that the cable drums are adequately supported by both drum flanges.

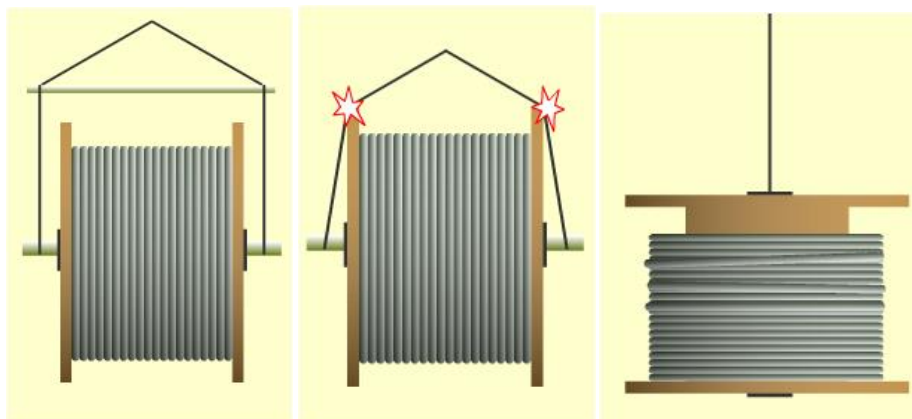
Some drums may be of sufficient length and weight to require cranes to load and unload from transport vehicles. In this case, it will be necessary to ensure that a spreader bar of sufficient length is used to ensure the lifting chains do not compress the drum flanges.

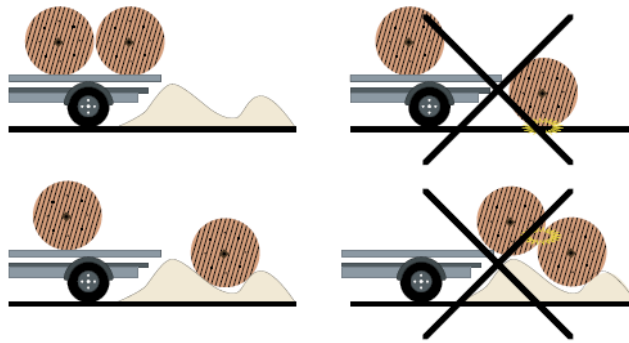
When forklift or crane is not available, a makeshift ramp with approximate inclination of 1:4 should be constructed. The cable drum should then be rolled over this ramp by means of ropes or winches. Additionally, a sand bed at the foot of the ramp can be built to brake the rolling cable drum.

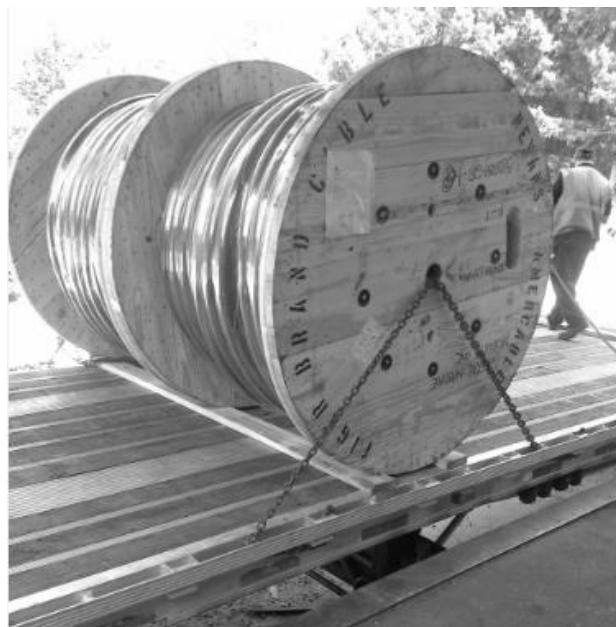
When the drums are loaded on trucks, binding must be made with ropes crossing through the central hole and if necessary on the drum flanges.

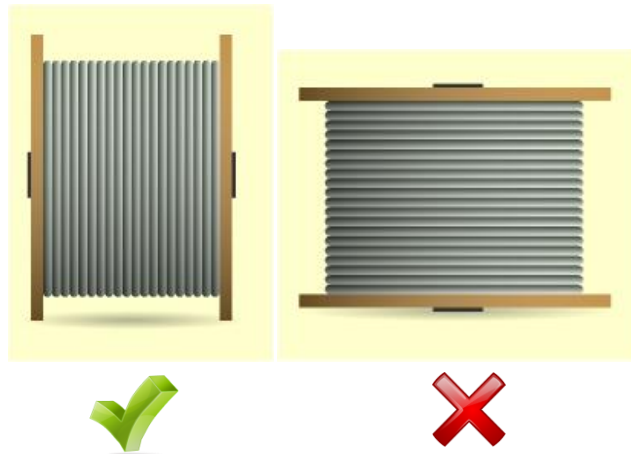
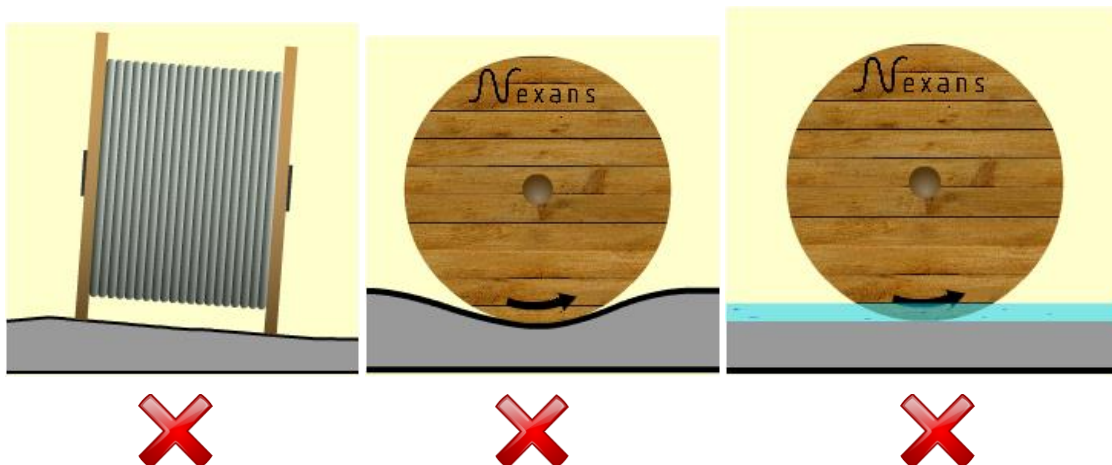
Drums should be stored on a level and firm surface (e.g. timber baulks, firm gravel, or concrete), on the flange edges (not with the flange flat on the ground), such that they will not be standing in water or in continually damp conditions, and restricted from rolling.

Failure to provide these conditions is likely to result in timber rot and weakening of the flange with potential breaks of the flange or collapse of the drum to the point where the cable itself will rest on the ground. Any of these outcomes will make installation of the cable more problematic or impossible.

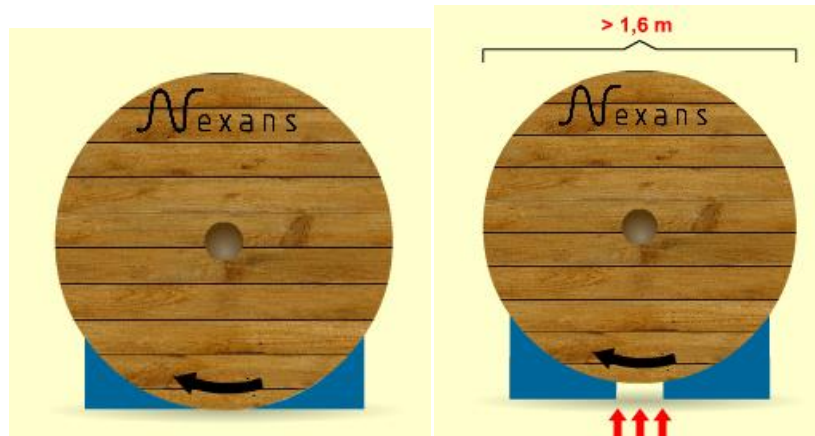
Wedges must be used to retain drums. Wedges must be positioned at flange edges and not between flanges. The use of stones are not recommended.

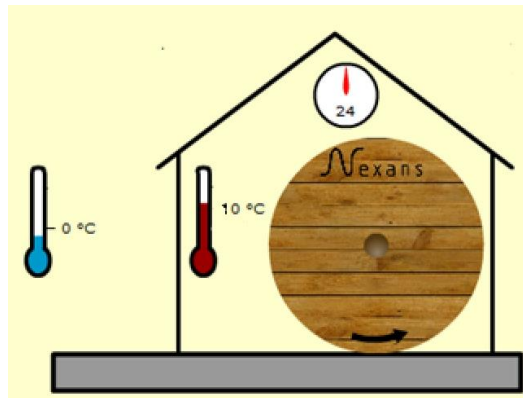
If the external temperature is below  $-5^{\circ}\text{C}$ , you should postpone cable pulling. If installation of cables is necessary, it is imperative to store them, before unreeling, in warmed room above  $+10^{\circ}\text{C}$  for at least 24 hours. Unreeling has to be done within 2 hours using a slow and regular speed (around 20m/minute) without shock.

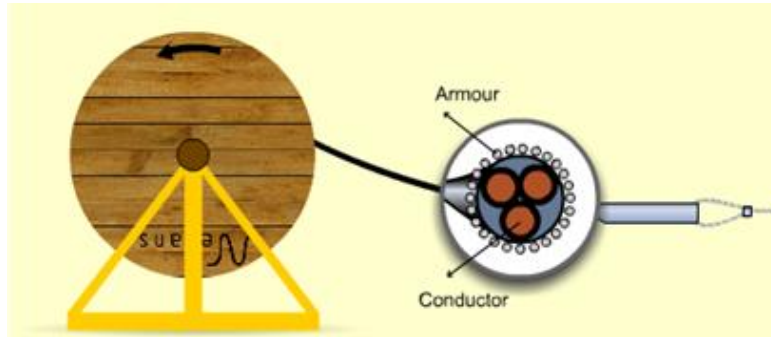
Cable ends will be protected by end caps or by pulling eyes. For longer lengths of cable (perhaps over 800 m) or for large conductor sizes (over 630 mm<sup>2</sup>), Nexans recommends the use of pulling eyes fixed to the main conductors of the cable. Pulling long and heavy cables by pulling socks can lead to cable or sheath damage.

The end caps and pulling eyes prevent moisture from entering the end of the cable and it is necessary to inspect the condition of the end cap or pulling eye when accessing the cable ends before the installation.

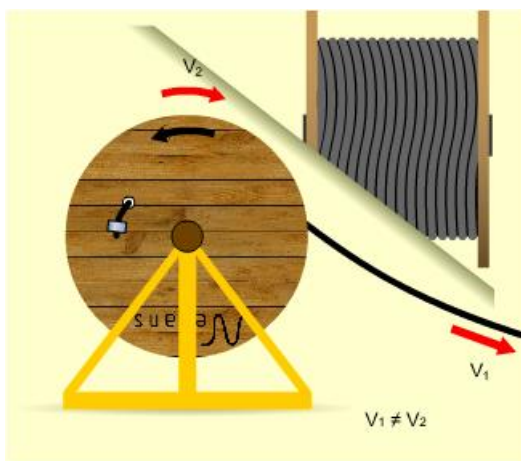
To avoid creepage and sinuous shape on the barrel of the drum during paying off, the inner end of the cable on the drum flange should be free, not fixed to the drum.

*Fixed Cable End – Creepage occurs*

The inside end of the cable has a tendency to creep through the hole in the flange when the drum is revolved in the opposite direction to that originally employed when winding the cable onto it. This tendency cannot be prevented. The amount of creepage depends on the length of the cable on the drum, the size of the cable and the number of times the drum is revolved. The accumulated slack due to unwinding long lengths of cable may amount to several metres. It can become extensive when the timber drums bolts have loosened or the timber has aged and shrinkage has taken place.

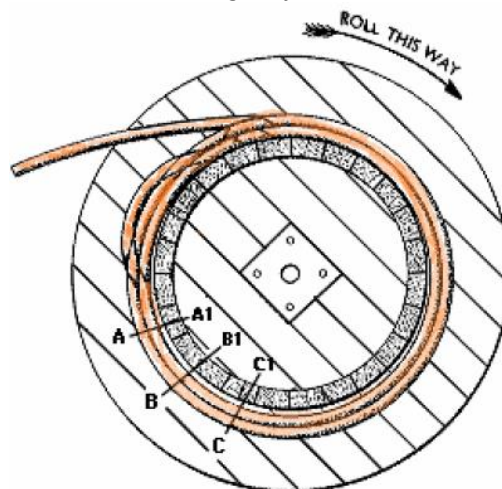
*Free Cable End – Extra length is formed outside*

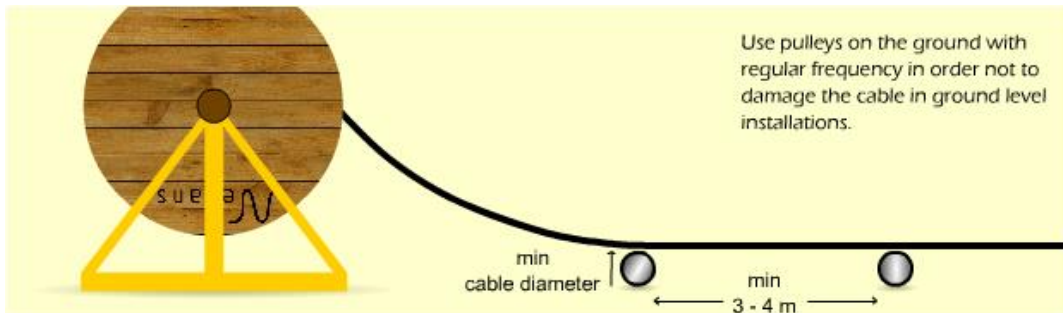
For long circuits, where long lengths or heavy cables are used, pulling tension calculations should be performed for each cable section. Pulling methodology should be prepared clearly detailing the drum position, position of winches or caterpushers, and the number and type of rollers to be employed. For direct buried installations, rollers should be used at 3-4 metre intervals, with more frequent rollers at bends

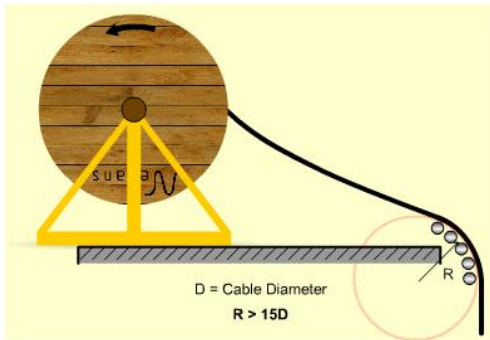
Ducting at cable bends must be selected so the curvature is not below the minimum bending radius during installation. When using rollers at cable changes in direction, it is recommended a number of rollers are used forming a radius that is larger than the minimum bending radius.
